## Scope of Work

## Trolley Lift Cable and Channel Repair Cost Estimate

### **Project Justification**

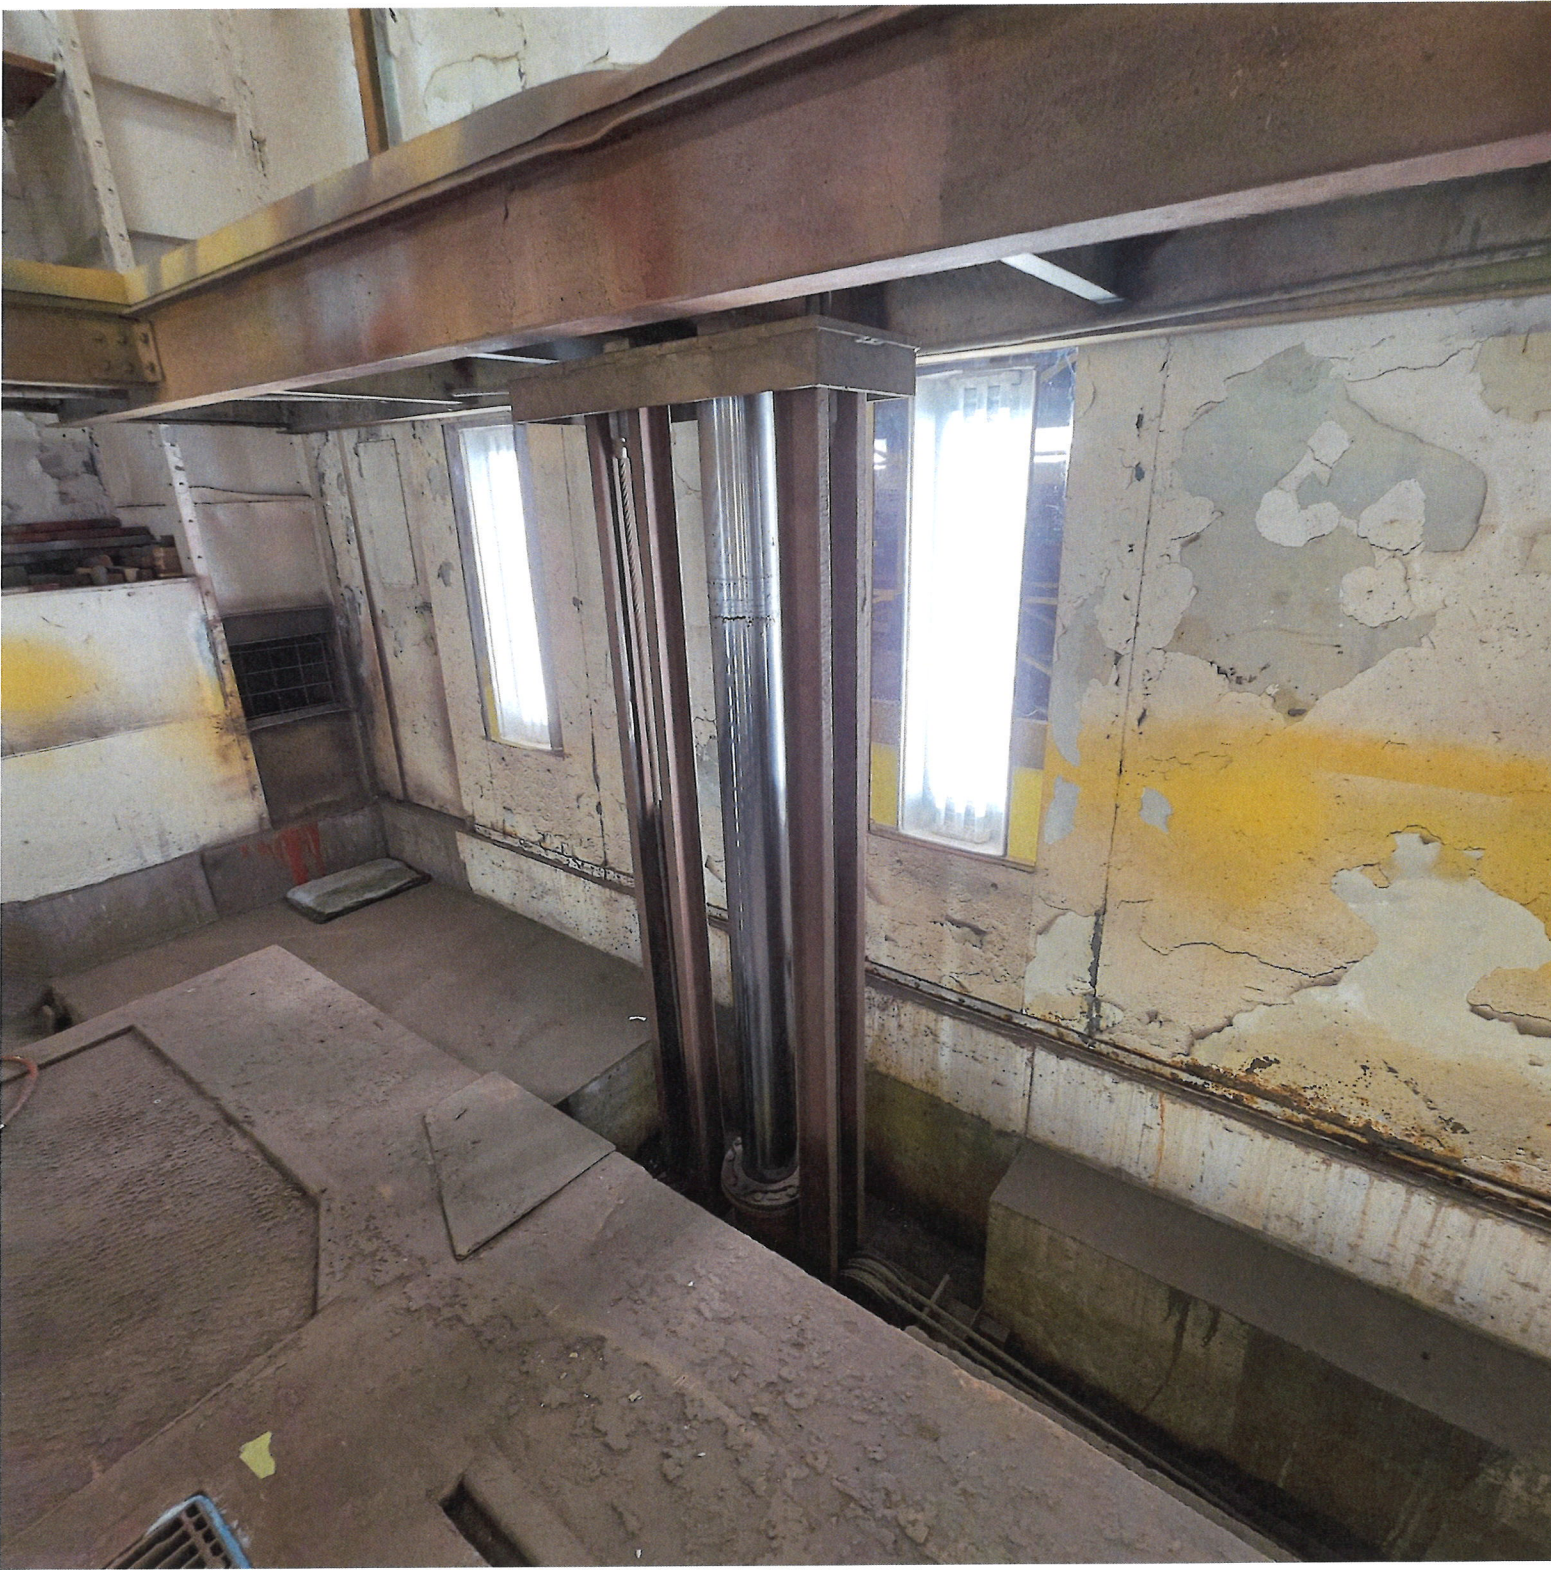
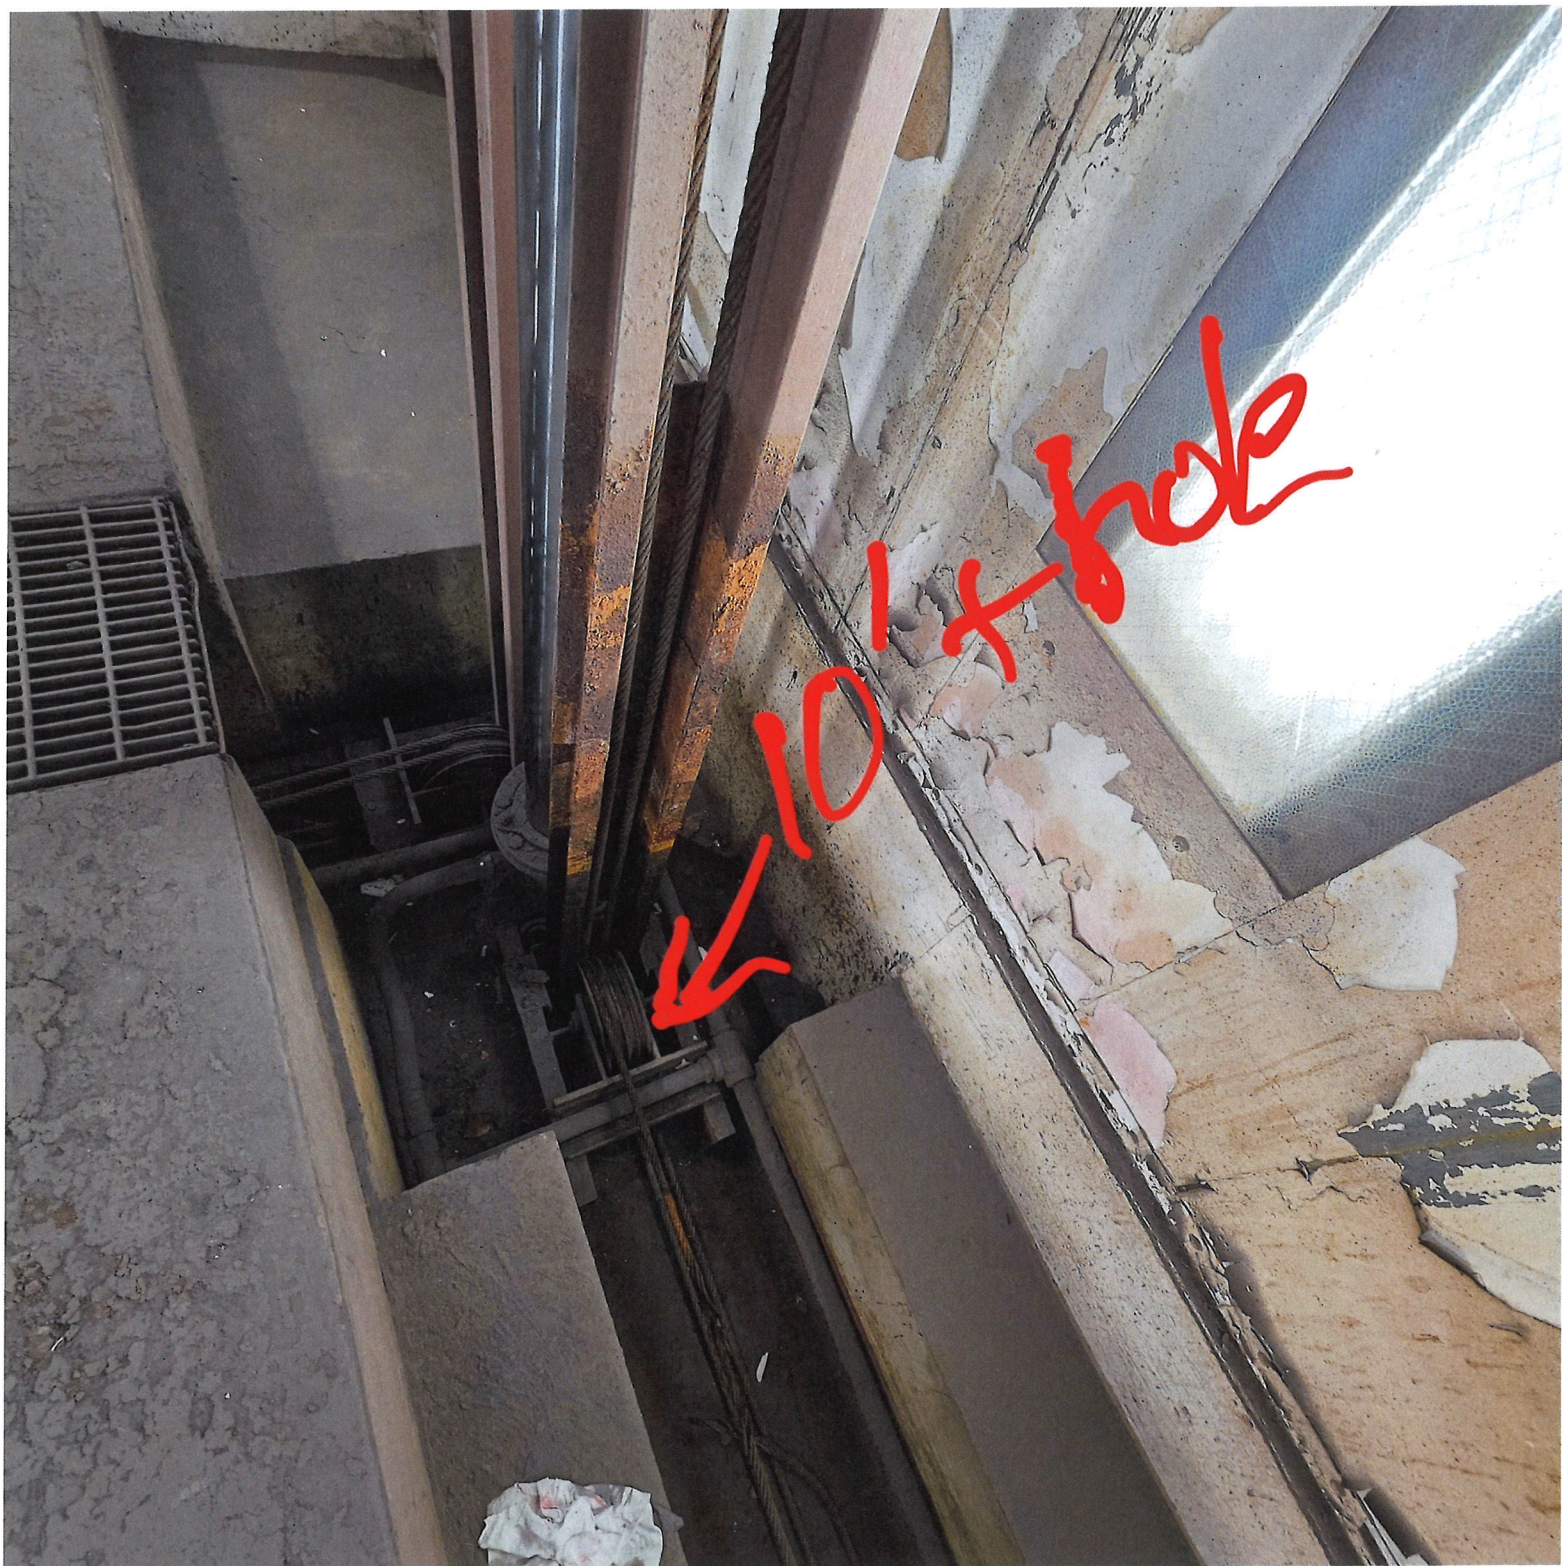
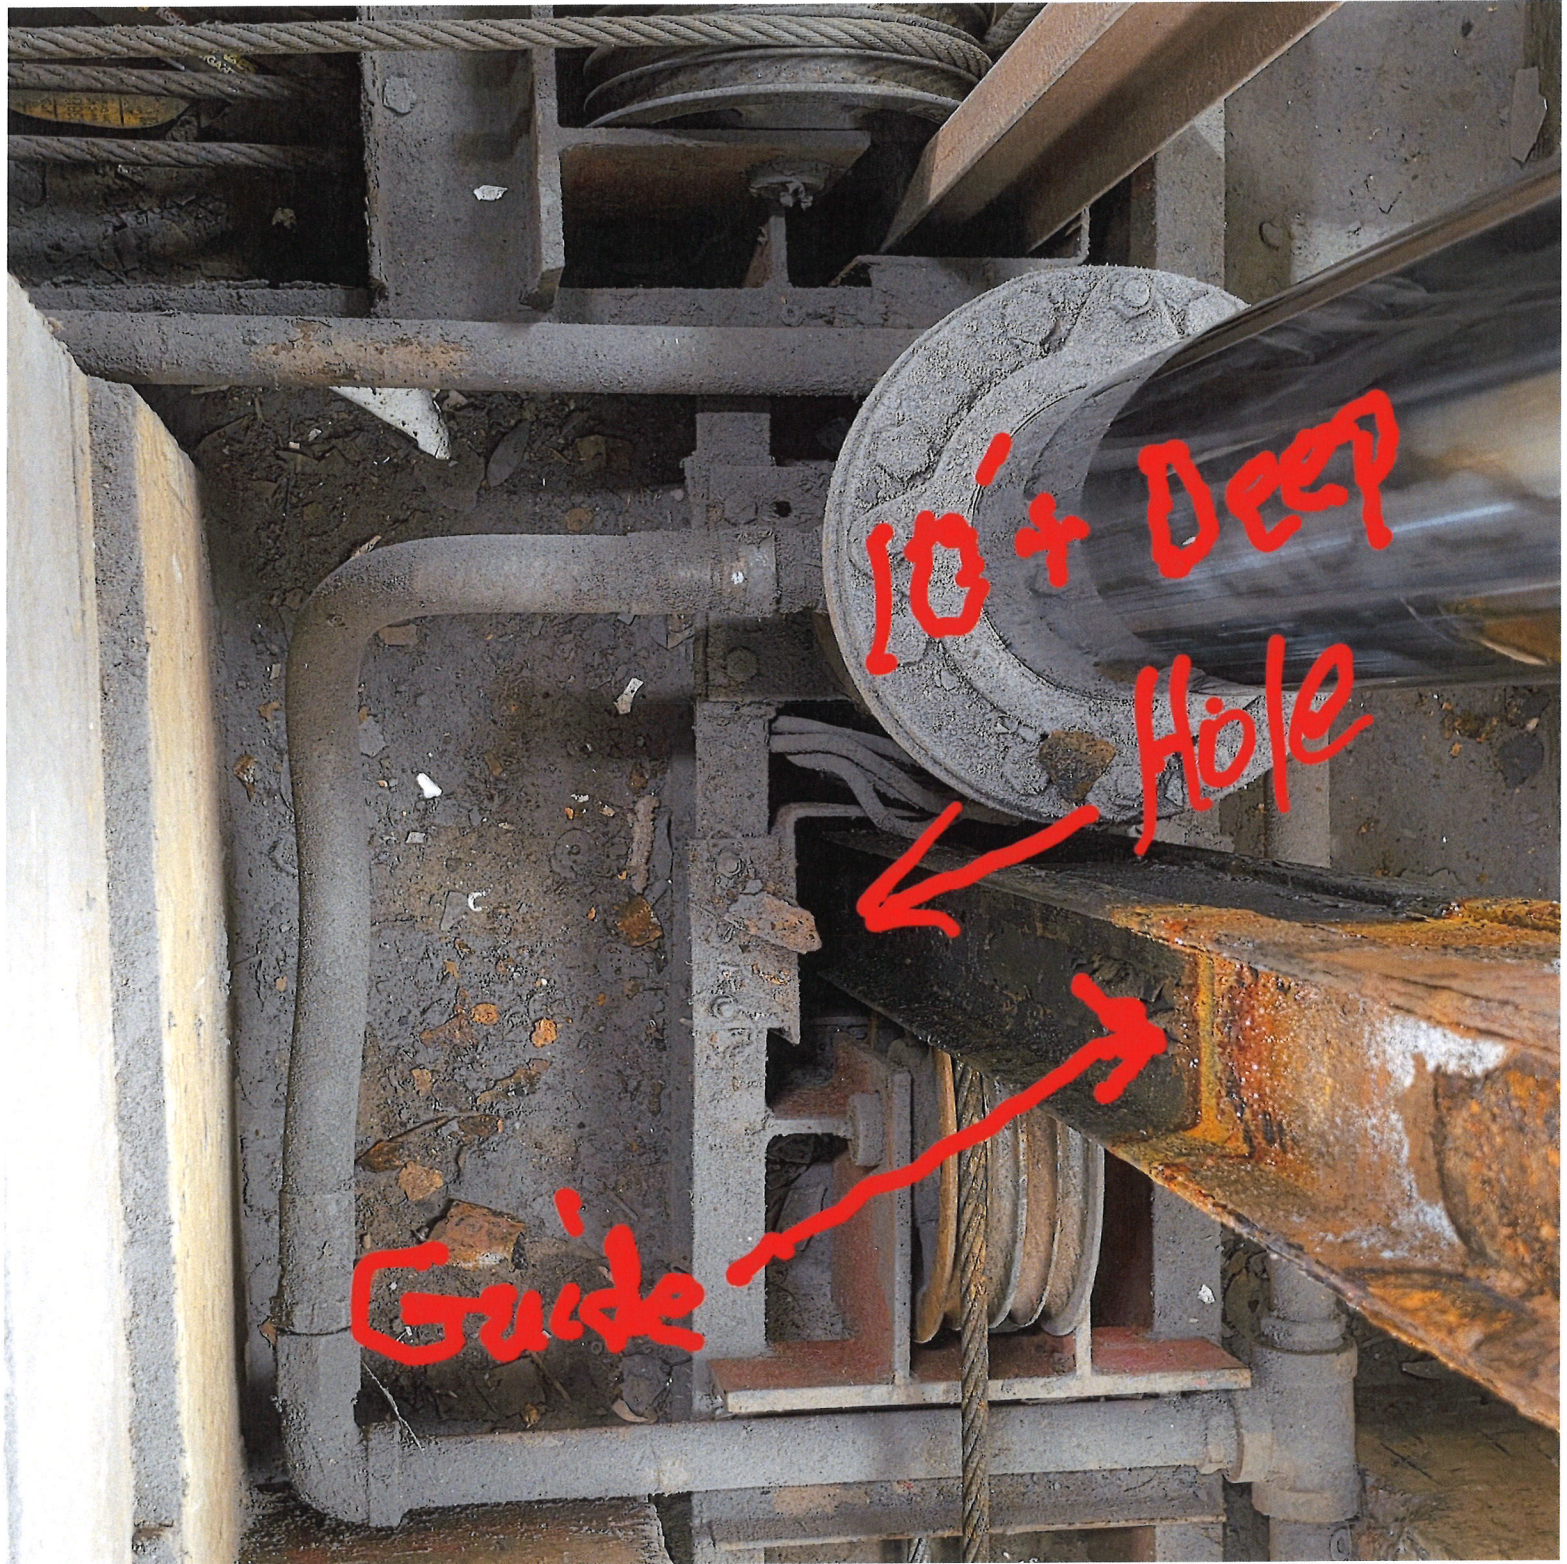
The trolley lift cable system in the paint booth is currently compromised due to a damaged/broken cable and structural components, creating a significant safety hazard and operational risk. Immediate repair is required to restore safe functionality and prevent potential equipment failure or injury.

10' + Deep  
Hole

Guide

- Install temporary support structures at all four corners of the lift to ensure stability and prevent unintended descent during repairs.
- Remove the existing upper plate and upright C-channel components.
- Remove and properly dispose of the damaged/broken lift cable.
- Fabricate and install a new upright C-Channel post to restore structural integrity.
- Install and secure a new trolley lift cable system in accordance with safety and operational standards.
- Perform inspection and testing to ensure the lift system is functioning safely and properly.
